**TECHNICAL REPORT :**  
**CORROSION IN DRY AND PREACTION SYSTEMS: PRELIMINARY RESULTS OF LONG-TERM  
CORROSION TESTING UNDER COMPRESSED AIR AND NITROGEN SUPERVISION**

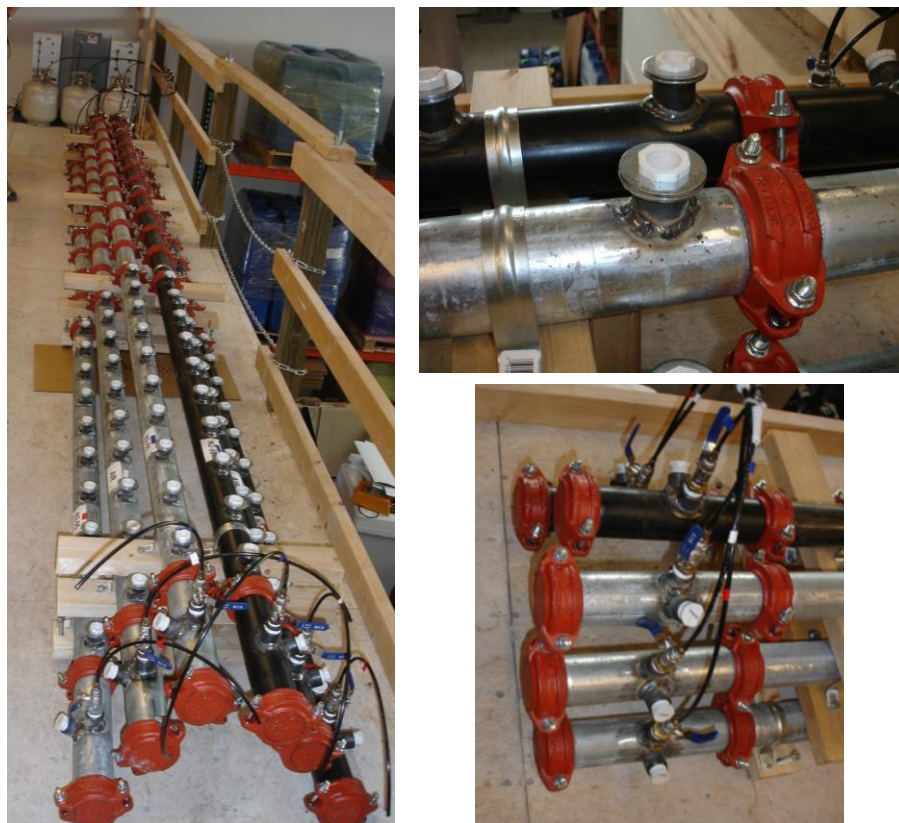
**Figure 1. Long-term exposure test setup.**

are individually subjected to either compressed air or 98% nitrogen supervision. This real-world experiment, consisting of materials that are currently used in dry and preaction sprinkler installations, has been conducted under carefully controlled and monitored conditions. These tests provide the first science-based data for evaluation of the effectiveness of nitrogen gas supervision. A composite of images of the test setup is shown in Figure 1.

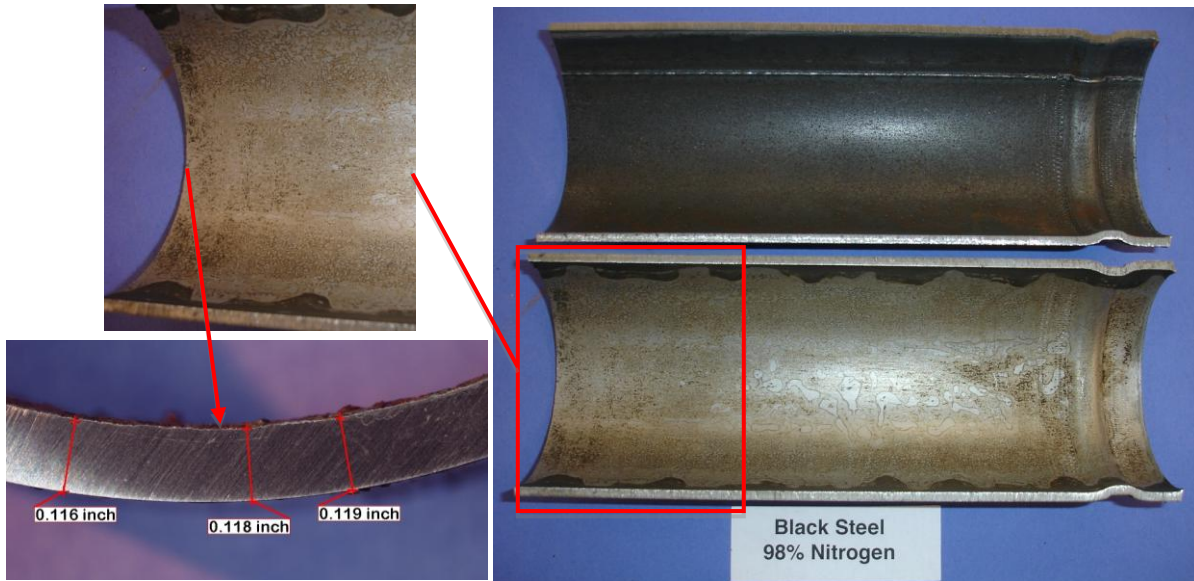
**Figure 4. Black steel piping after 498 days exposure while half-filled with water and 98% nitrogen supervision. Note uniform appearance of pipe wall and absence of any localized pits.**
